PHOTOGRAPHIC SURVEY OF THE LDEF MISSION

National Aeronautics and
Space Administration

NASA Special Publication 531
1996

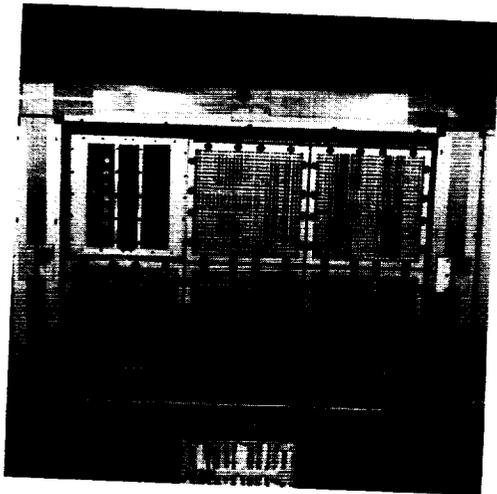
Figure 414
Photo No.: KSC-390C-1035.05
Dup. Neg. No.: L90-13450
LISAR No.: EL-1994-00183
Photo Credit: KSC
Photo Date: 2/9/90
Location: KSC SAEF II
Subject: Postflight Survey of Tray E5

Figure 414 (Postflight). The experiment hardware appears to be without physical damage.
